# Manhole Inspection Summary

Manhole # S13A\_\_037MH

Insp Date: **1/14/09 1:56 PM**

**Location** Address: **2810 LANVALE ST**

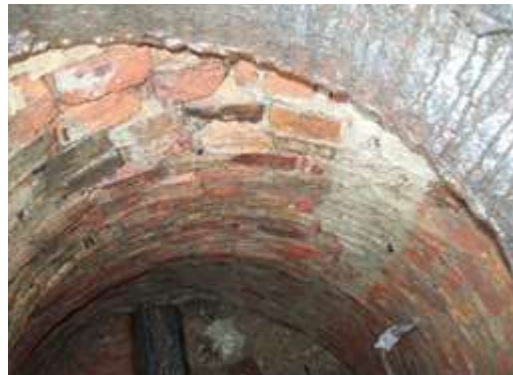
Defect 5

Condition: ☐ Sound ☐ Cracked ☐ Root Intrusion ☐ Loose Brick ☒ **Deteriorated**

DETERIORATED BARREL

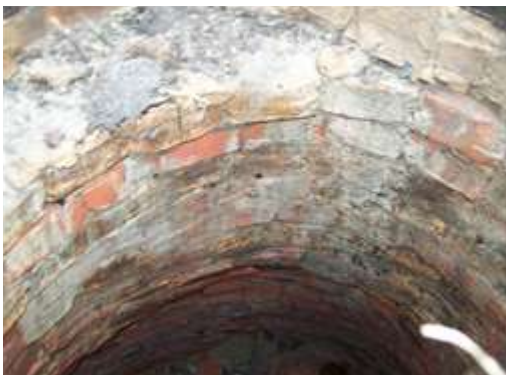
Defect 4

Condition: ☐ Sound ☐ Cracked ☐ Root Intrusion ☒ **Loose Brick** ☒ **Deteriorated**

Infiltration: ☐ None ☐ Joint ☐ Cracks ☐ Mortar ☐ Roots ☒ **Wall**

LOOSE BRICKS AND DETERIORATED CORBEL AND INFILTRATION

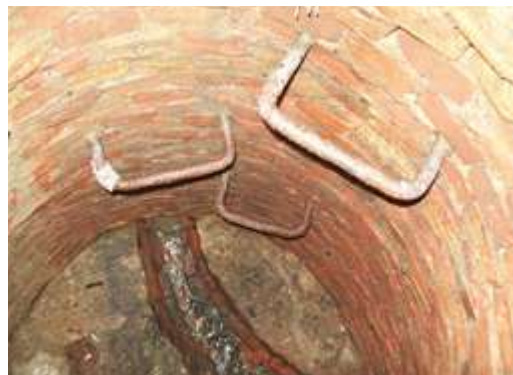
Defect 3

☒ **Evidence Of Surcharge** Depth: **2** (ft.) ☐ Active Surcharge Present

EVIDENCE SURCHARGE

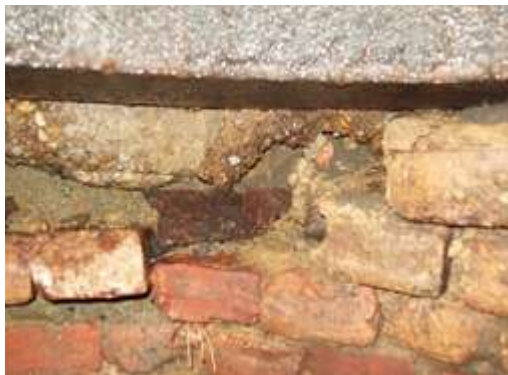
### Defect 2

Condition: ☐ Sound ☐ Cracked ☐ Root Intrusion ☐ Loose Brick ☒ **Deteriorated**

DETERIORATED CHIMNEY
